TECHNICAL REPORT ◦ JUNE 2024

Fish Passage Barrier Assessment in the Upper Arroyo Seco

PREPARED FOR
Arroyo Seco Foundation
PO Box 91622
Pasadena, CA 91109

PREPARED BY
Stillwater Sciences
996 S. Seaward Avenue, Suite 102
Ventura, CA 93001

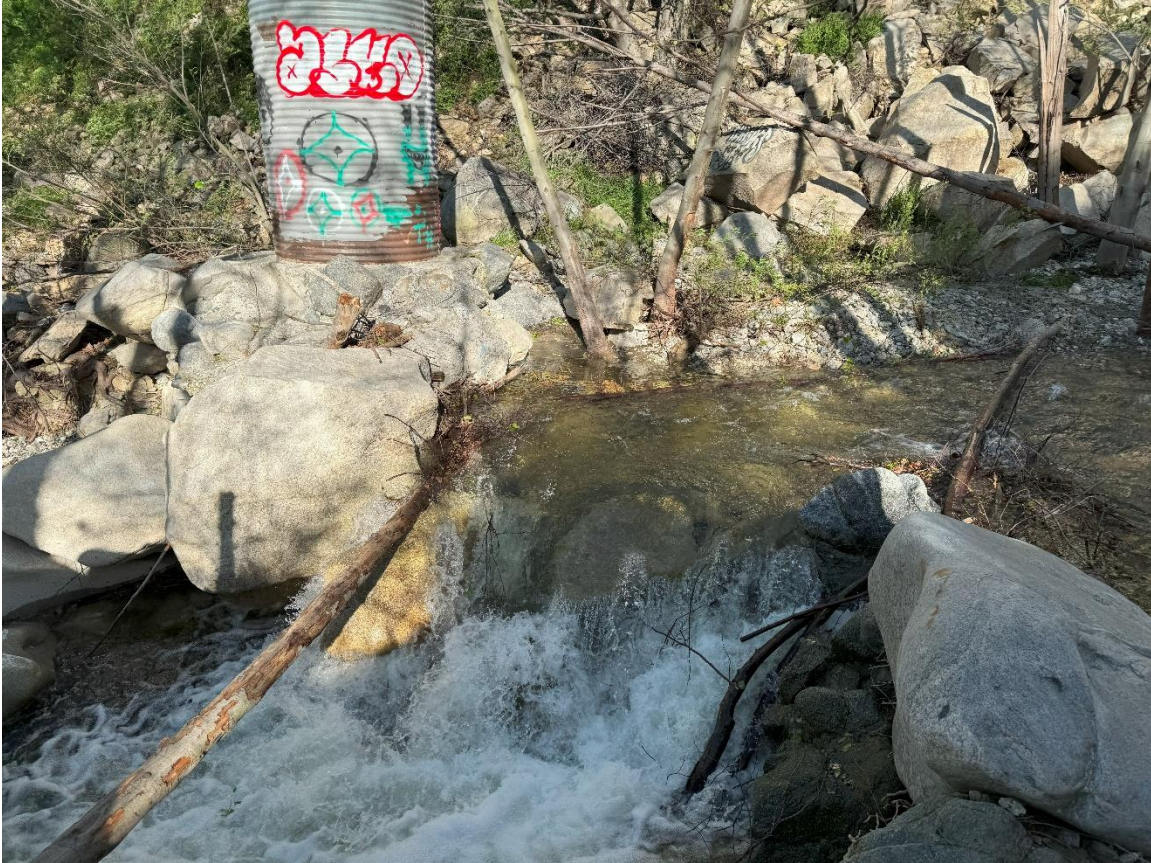
4.2.1 Potential natural barrier (river mile 1.49)

The first potential barrier upstream of the JPL bridge is a small natural waterfall about 3 feet (ft) in height at RM 1.49. This is the only natural barrier of the 12 barriers assessed during this survey. The natural barrier could be a partial physical barrier to upstream migration, especially for smaller-sized juveniles or any life stage during periods of low flow.

Figure 4. Potential natural barrier at river mile 1.49.

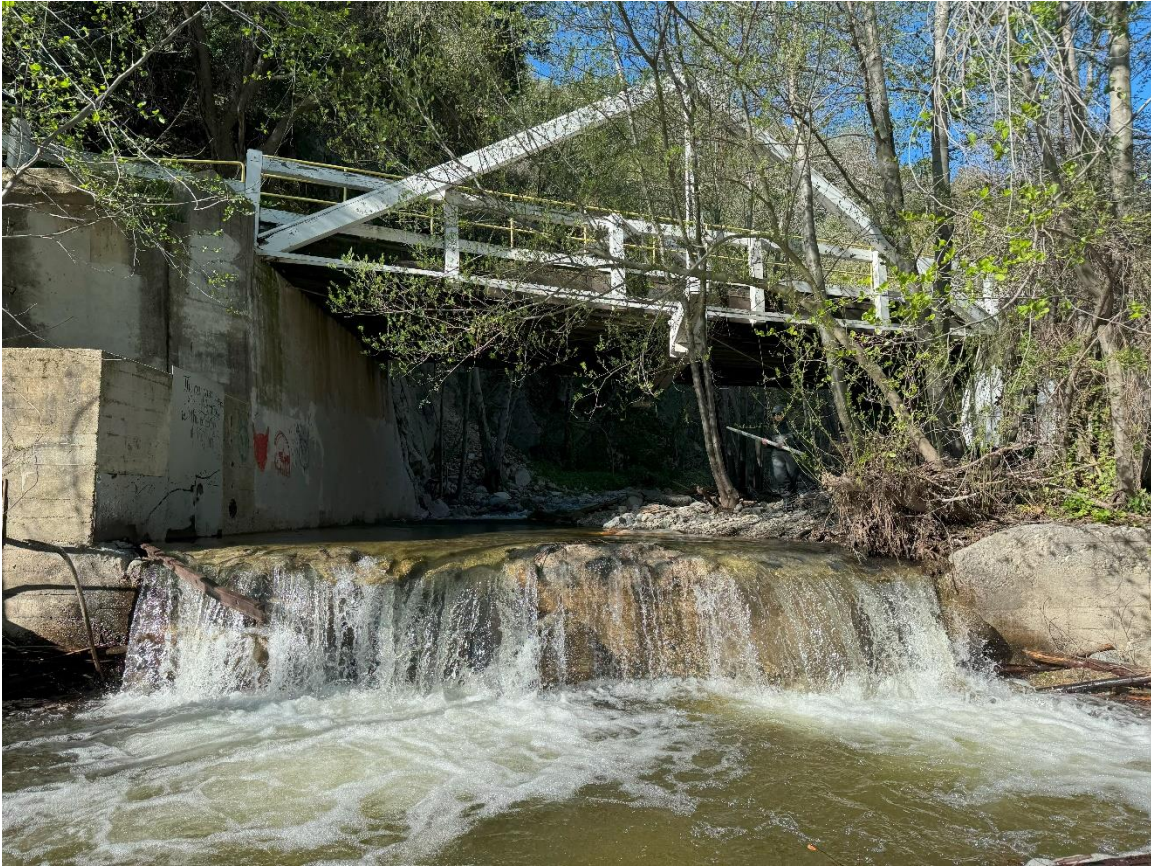
4.2.2 First crossing (river mile 1.71)

The first crossing is a concrete apron under a bridge located at RM 1.71. The head height is about 4.5 ft, which is uniform for about 5 ft, and then there is a deep pocket near the concrete wing. The length of the barrier, measured from the downstream end to the upstream end of the structure, is a 34-ft run with some deep spots and a sand and gravel sediment bottom. This barrier is next to the road and has vehicle access. The first crossing barrier is likely a total physical barrier to upstream passage for most fish under most flows, but certainly for smaller fish and under low flows. Larger-sized fish may be able to pass under some flow conditions due to the deep pool depth downstream. The 34-ft run immediately upstream from the drop structure could also be a velocity barrier under high flows.

Figure 5. First crossing at river mile 1.71.

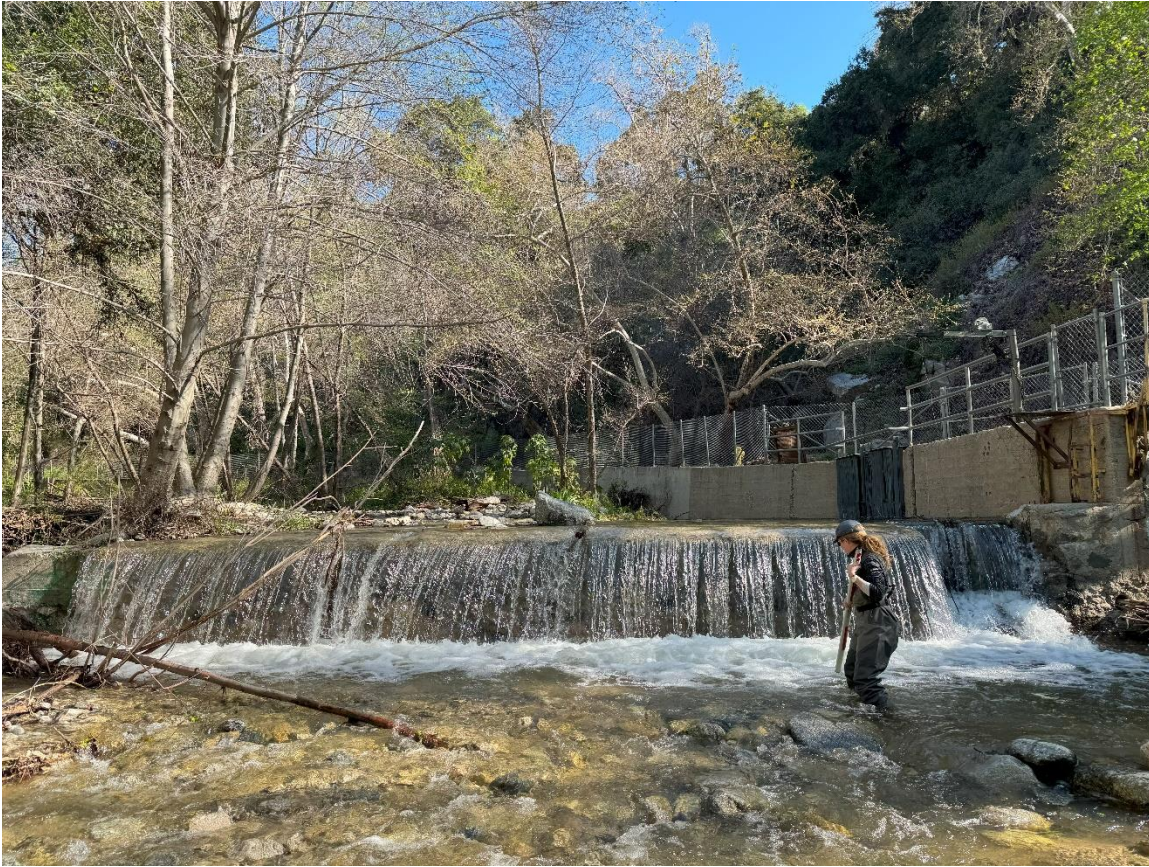
4.2.3 Pasadena Water and Power diversion weir (river mile 1.81)

The PWP diversion weir, located at RM 1.81, is a concrete wall with a 2.5-ft lip of concrete at the top and a natural bottom that becomes shallow upstream. There is a notched feature on the left bank (looking upstream). Very little cover exists in the pool downstream of the diversion. On March 13, 2024, an *O. mykiss* was observed attempting to jump over the barrier, but it was unsuccessful. Typically, the stream seasonally dries upstream of the diversion weir halfway to USGS Gage #11098000, especially in drought years (J. Stanovich, CDFW, pers. comm., March 14, 2024). The diversion is adjacent to the road with vehicle access. Overall, the PWP diversion weir is likely a total physical barrier to upstream movements of fish, regardless of flow and life stage.

Figure 6. Pasadena Water and Power diversion weir at river mile 1.81.

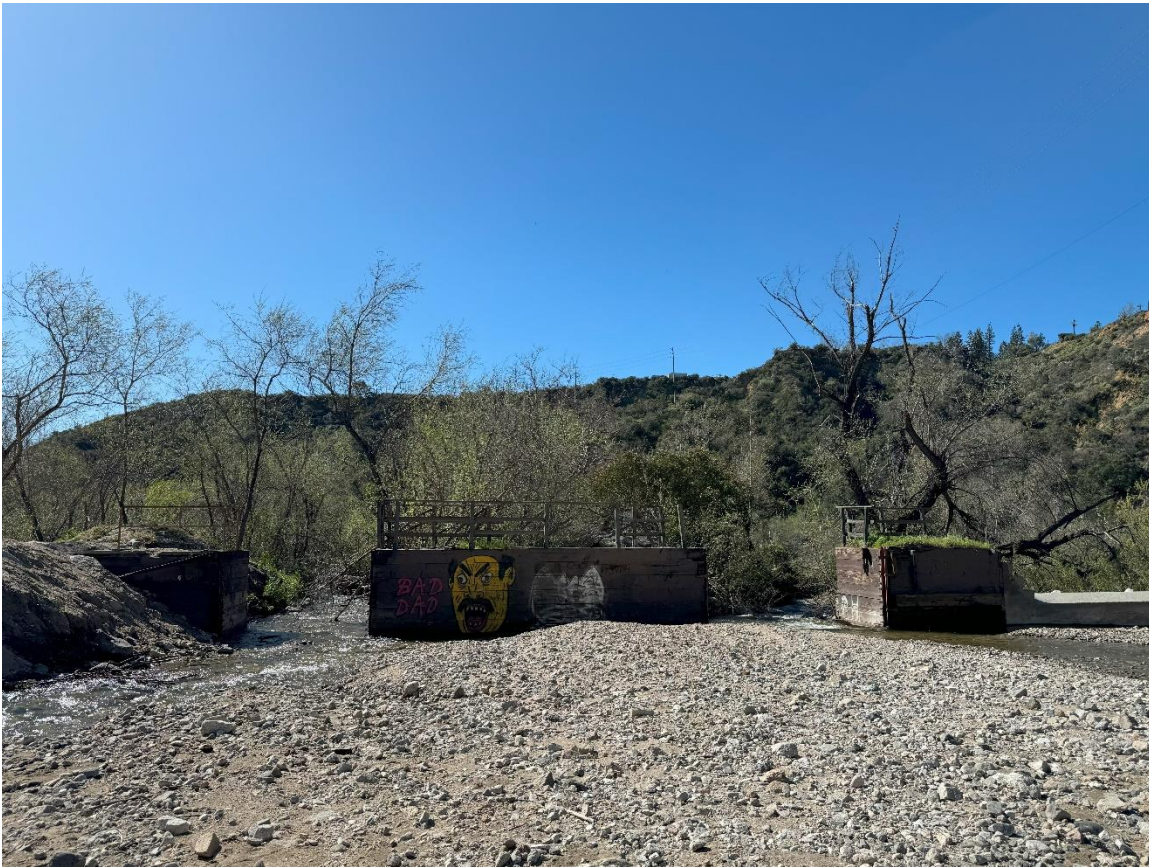
4.2.4 Sediment headworks (river mile 2.19)

The sediment headworks, located at RM 2.19, have a large concrete center block that splits the stream into two channels. The left bank has a drop caused by boulders on a diagonal, which could be passable by fish under certain flows. There are boulders, a bubble curtain, and a narrow channel downstream. The right bank does not have a drop, but vegetation is dense and chokes the river approximately 40 ft downstream. The two channels meet about 0.1 mile downstream of this barrier. Prior to surveys, the area downstream of the headworks in low-flow conditions was highly silty and had log jams and standing water (J. Stanovich, CDFW, pers. comm., March 14, 2024), and now the area has riffle habitat with rocks and non-uniform flow. The channel was rerouted by the City of Pasadena following heavy rains to maintain the adjacent road, and sediment berms were created on the right bank. The measurements in Table 1 (provided at the end of this section) are for the left bank. It is possible that the stream may reroute in the future. Water goes subsurface downstream of this barrier under low flow conditions. There is good vehicle access to this barrier on the adjacent road. Overall, the sediment headworks barrier is a partial physical barrier to upstream migration, especially for smaller-sized juveniles or during periods of low flow.

Figure 7. Sediment headworks at river mile 2.19.

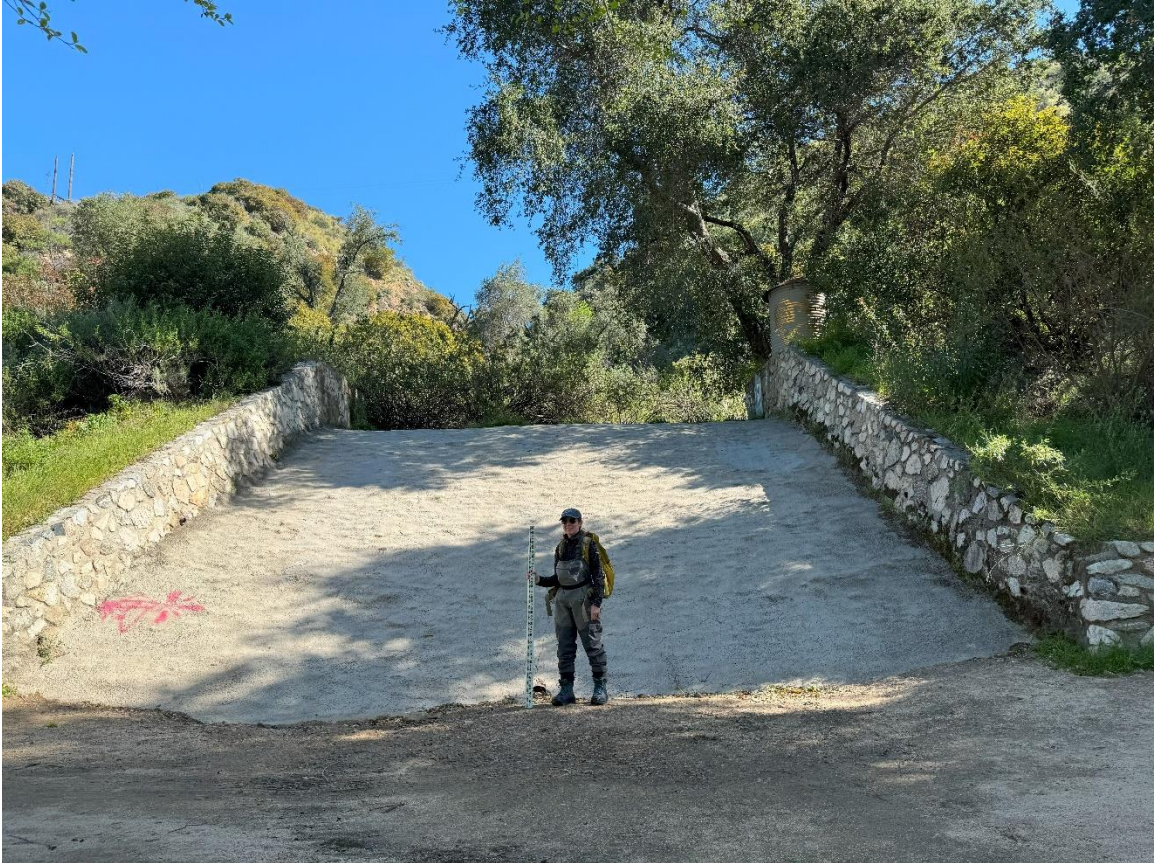
4.2.5 Tributary canyon (river mile 2.32)

The tributary canyon barrier is located in a tributary to Arroyo Seco (the confluence is located at RM 2.32). The barrier's purpose is unknown. During the survey, the tributary was dry, and no suitable *O. mykiss* habitat was available upstream. There was some sediment in the downstream end, indicating that in the past water has flowed in this location. Because the tributary is assumed to be dry most of the time, it is concluded that the tributary canyon is not in fact a barrier to fish passage.

Figure 8. Tributary canyon at river mile 2.32.

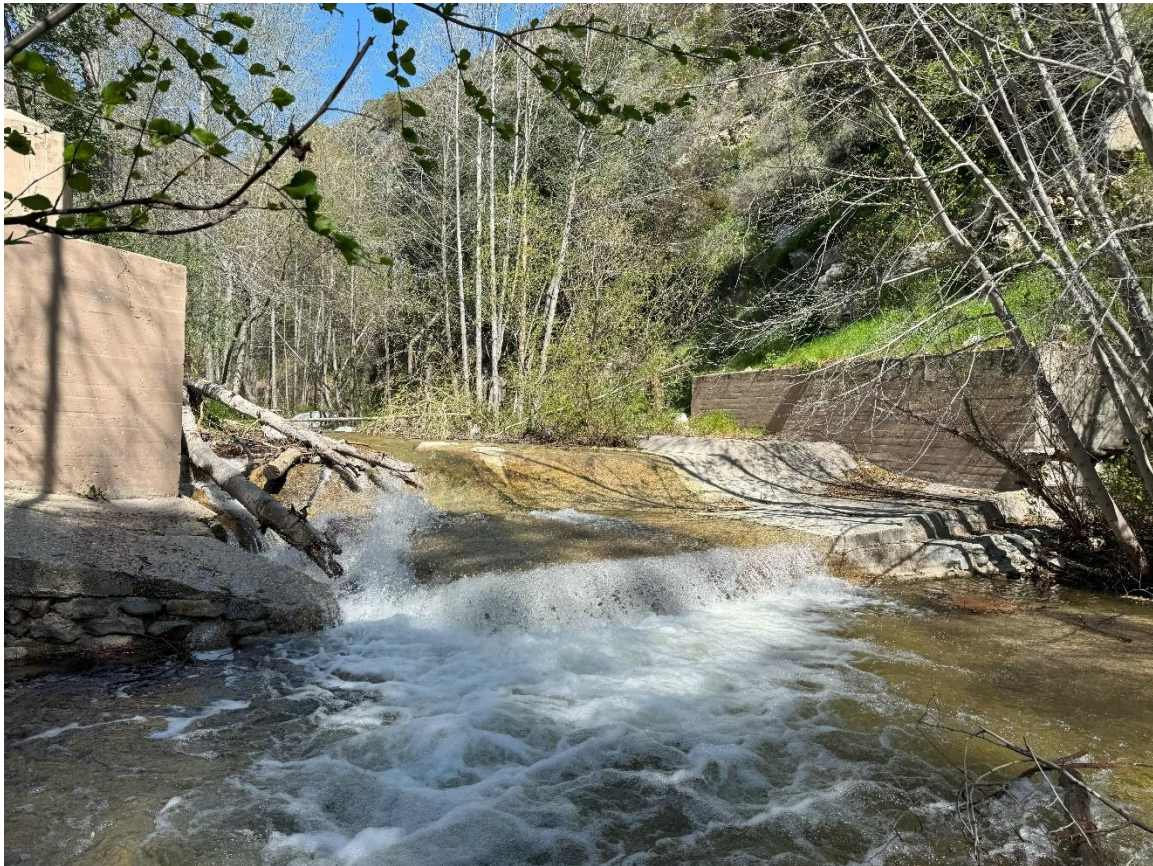
4.2.6 USGS Gage #11098000 (river mile 3.43)

USGS Gage #11098000, located at RM 3.43, is a large concrete slab with a two-step face. During the survey, it had a few inches of water cascading over the top step and a log jam at the top of the barrier. A crack on the left bank has a deep undercut, and the deepest part of the downstream pool is inside the crack. Stillwater scientists observed *O. mykiss* at this location during site visits in 2022 (Stillwater unpubl. data) and the Arroyo Seco Foundation has consistently observed fish in this pool during surveys (The Arroyo Seco Foundation unpubl. data). The high-quality habitat upstream of this barrier makes it a good candidate for replacement or modification to improve fish passage. Vehicle access is available via the adjacent road and the nearby Gould Mesa Campground. The USGS gage is a partial physical barrier to upstream migration, and the sheet flow over the concrete could create a velocity barrier during high flows. The barrier is located adjacent to Gould Mesa Campground, which is accessible to vehicles via a private service road. All barriers upstream of USGS Gage #11098000 can be reached only on foot using a hiking trail (i.e., not accessible to vehicles), unless otherwise stated.

Figure 9. USGS Gage #11098000 at river mile 3.43.

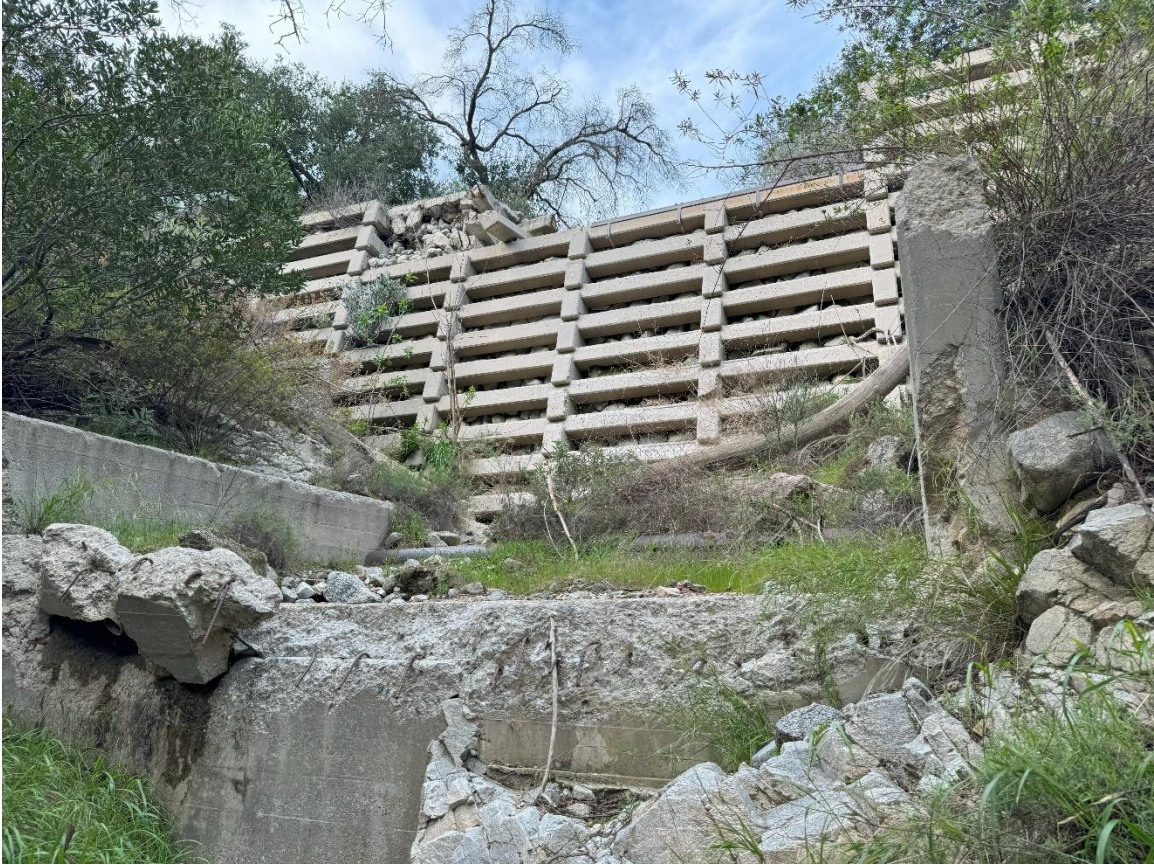
4.2.7 Debris dam on western tributary (river mile 3.93)

The debris dam is a 40-ft high dam with rocks on a high-gradient tributary of the Arroyo Seco on the west side of the stream at RM 3.93. The tributary is assumed to be dry most of the time; therefore, it is concluded that the debris dam is not a barrier to fish passage.

Figure 10. Debris dam on western tributary at river mile 3.43.

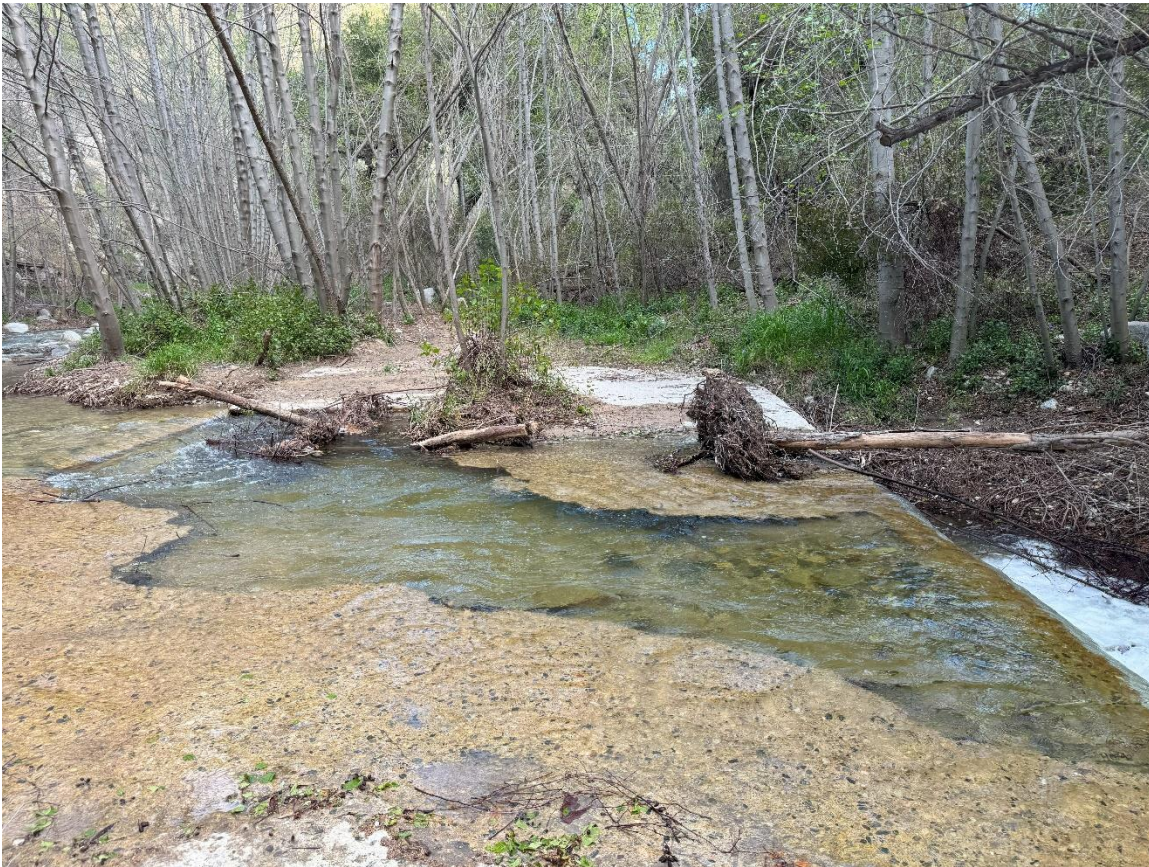
4.2.8 Arizona crossing (river mile 4.23)

An Arizona crossing is a roadway that crosses a stream. The first and farthest downstream Arizona crossing within the Study Area is located at RM 4.23; it is scoured in the center and has major undercutting on either side. The scoured area was filled with sediment. Juvenile fish were observed in the scoured area and downstream of the barrier, likely *O. mykiss* because that is the only fish species known to be present within the Study Area (J. Stanovich, CDFW, pers. comm., March 15, 2024). Gravels were observed upstream, downstream, and inside the scoured portion of the barrier and could be used for spawning. This barrier no longer serves its intended purpose; it was built so that vehicles could cross the stream, but vehicle access to this area is no longer available. Furthermore, it could create public safety issues during high flows, and people crossing the stream at this location could disturb spawning habitat. Overall, this is a partial physical barrier to upstream migration and most likely prevents upstream migration during periods of low flows, especially for smaller-sized juveniles.

Figure 11. Arizona crossing at river mile 4.23.

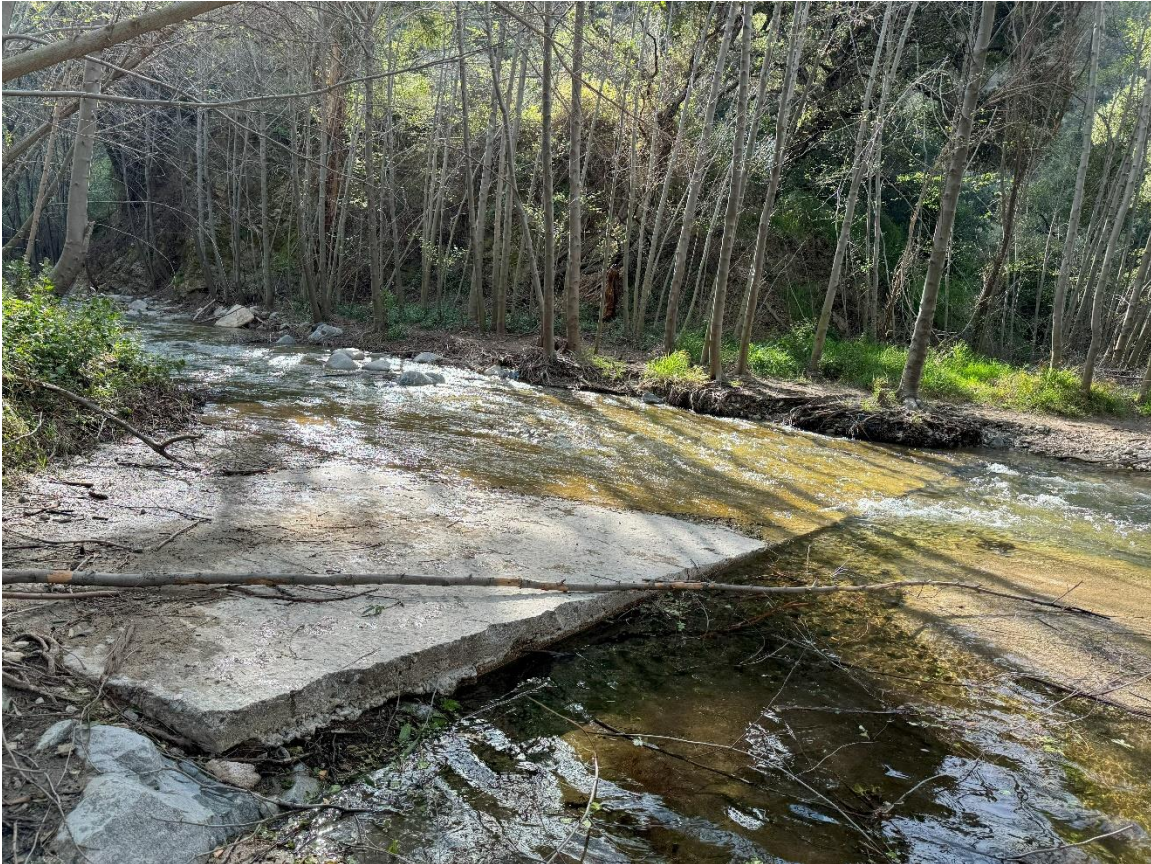
4.2.9 Arizona crossing (river mile 4.30)

The second Arizona crossing, located at RM 4.30, is a low concrete slab that has started to scour in the center. The scouring was not obvious during CDFW surveys last year in 2023 (J. Stanovich, CDFW, pers. comm., March 15, 2024), so it may have started less than a year ago. The concrete slab can create a sheet flow that would create a partial velocity barrier to upstream fish passage during high flows. There was no pool on the downstream side. Some gravels were available nearby, but very little cover. This barrier is not as large as the downstream Arizona crossing, but they are located very close together, so it may be possible to remove both at the same time. Scour downstream could create a total barrier in the future.

Figure 12. Arizona crossing at river mile 4.30.

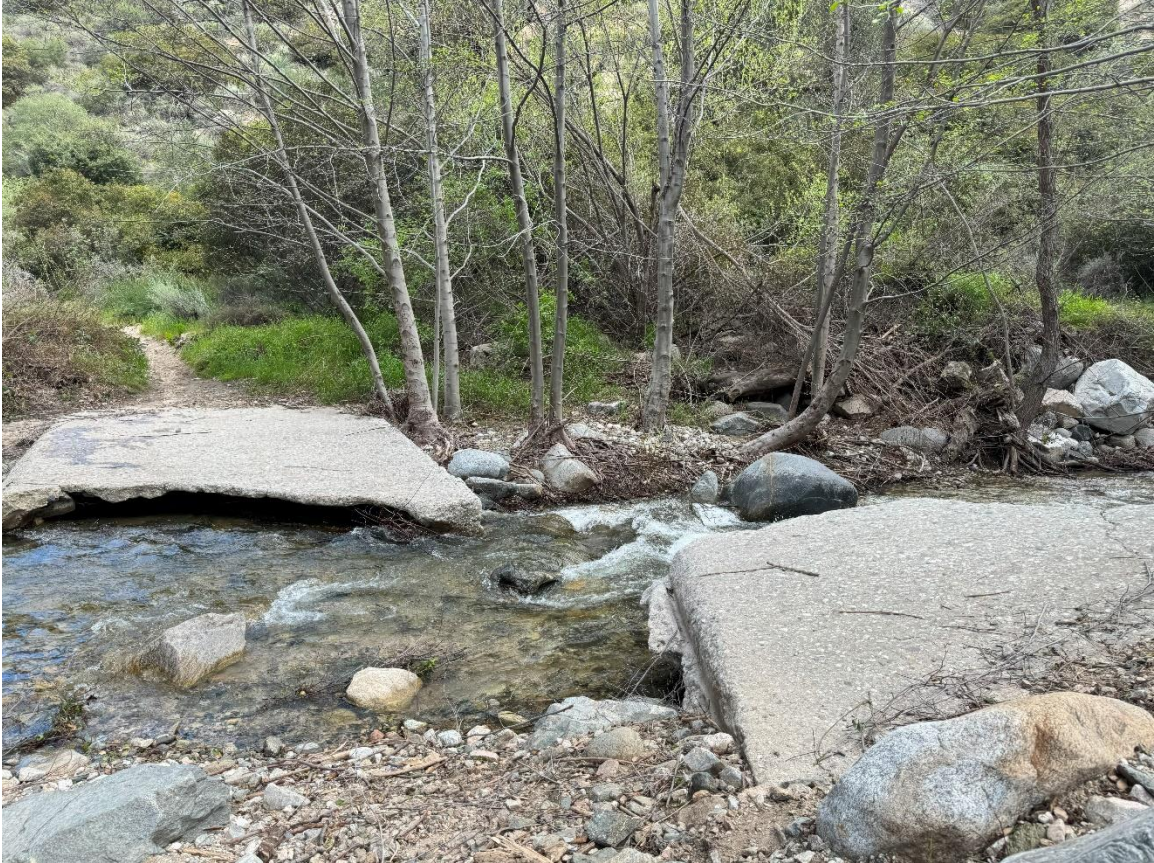
4.2.10 Deteriorated Arizona crossing (river mile 4.85)

The third Arizona crossing, located at RM 4.85, was not considered a barrier at the time of the survey because the concrete slab has deteriorated naturally. The remaining pieces are a 7-ft x 10-ft slab (left bank) and a 13-ft x 20-ft slab (right bank), which are somewhat choking the river, but fish can still pass through them. The concrete on the right bank is undercut, creating potential habitat for *O. mykiss*. During a previous site visit (September 5, 2018), Stillwater staff noted that if logs and debris were to become trapped in the concrete, they could potentially block fish passage.

Figure 13. Deteriorated Arizona crossing at river mile 4.85.

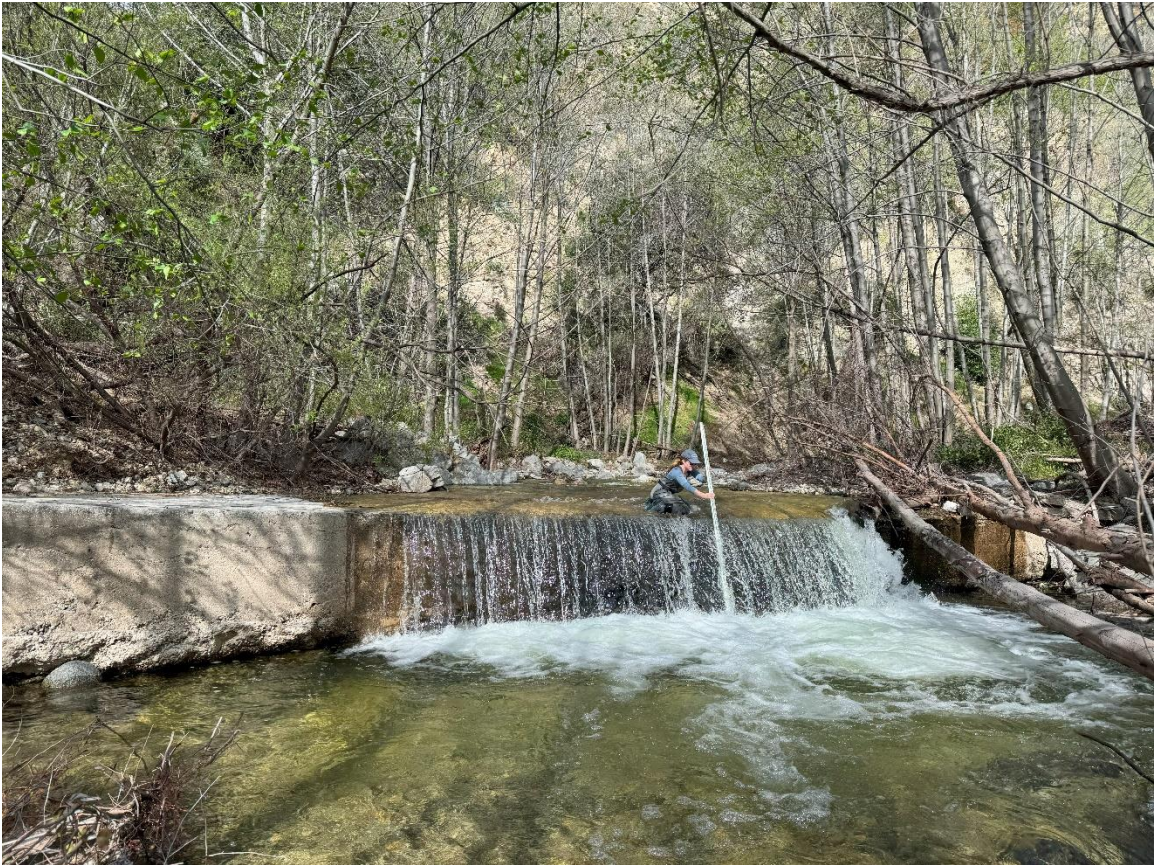
4.2.11 Arizona crossing (river mile 4.91)

The fourth Arizona crossing, located at RM 4.91, was not found during the initial desktop review of potential barriers but was observed during the field survey. It is a thick concrete slab that creates a total physical barrier to upstream passage to all life stages under all flows. At least six *O. mykiss* were observed in the pool downstream of this barrier during the field survey. This barrier would be difficult to remove logistically because it is not on a trail, it is located far from any areas with vehicle access, and vegetation surrounds the barrier. Possible solutions include notching the barrier or breaking up the concrete and leaving the pieces in the stream.

Figure 14. Arizona crossing at river mile 4.91.

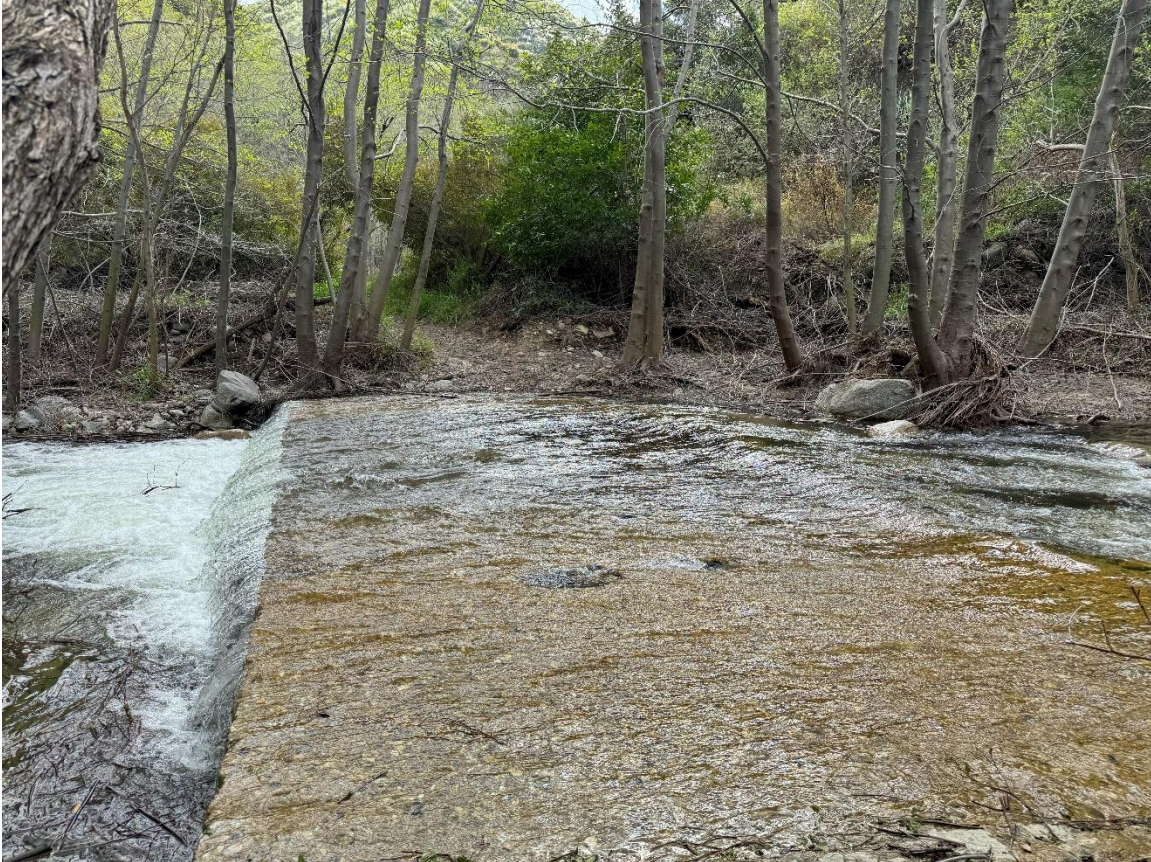
4.2.12 Arizona crossing (river mile 5.19)

The fifth Arizona crossing, located at RM 5.19, is a concrete slab that is starting to deteriorate on top. This barrier is relatively low and may be low enough for larger-sized fish to jump but would be a physical barrier to upstream migration for smaller-sized juveniles. The sheet flow over the concrete slab could also be a velocity barrier under high flows. Additional scour downstream could create a total barrier in the future.

Figure 15. Arizona crossing at river mile 5.19.
