TECHNICAL REPORT ◦ JUNE 2024

Fish Passage Barrier Assessment in the Upper Arroyo Seco

PREPARED FOR
Arroyo Seco Foundation
PO Box 91622
Pasadena, CA 91109

PREPARED BY
Stillwater Sciences
996 S. Seaward Avenue, Suite 102
Ventura, CA 93001

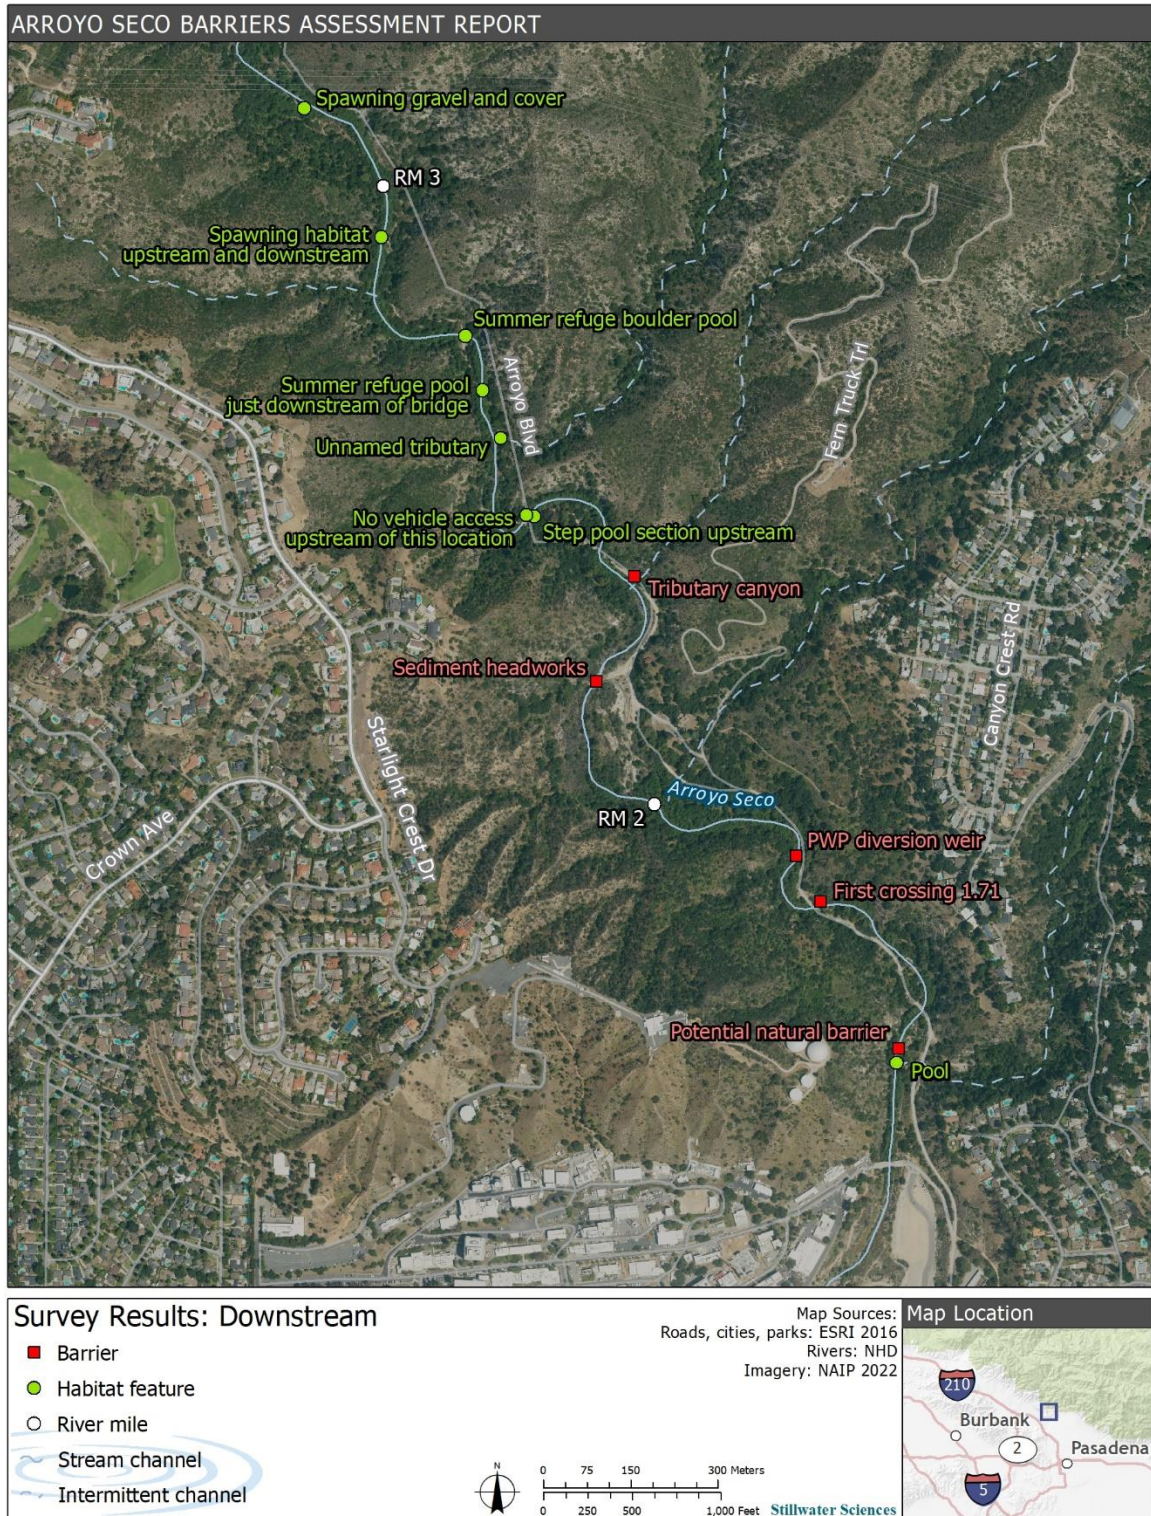
Figure 2. Barrier assessment survey results within the downstream reach of the Arroyo Seco, including significant habitat features also identified during the field survey.

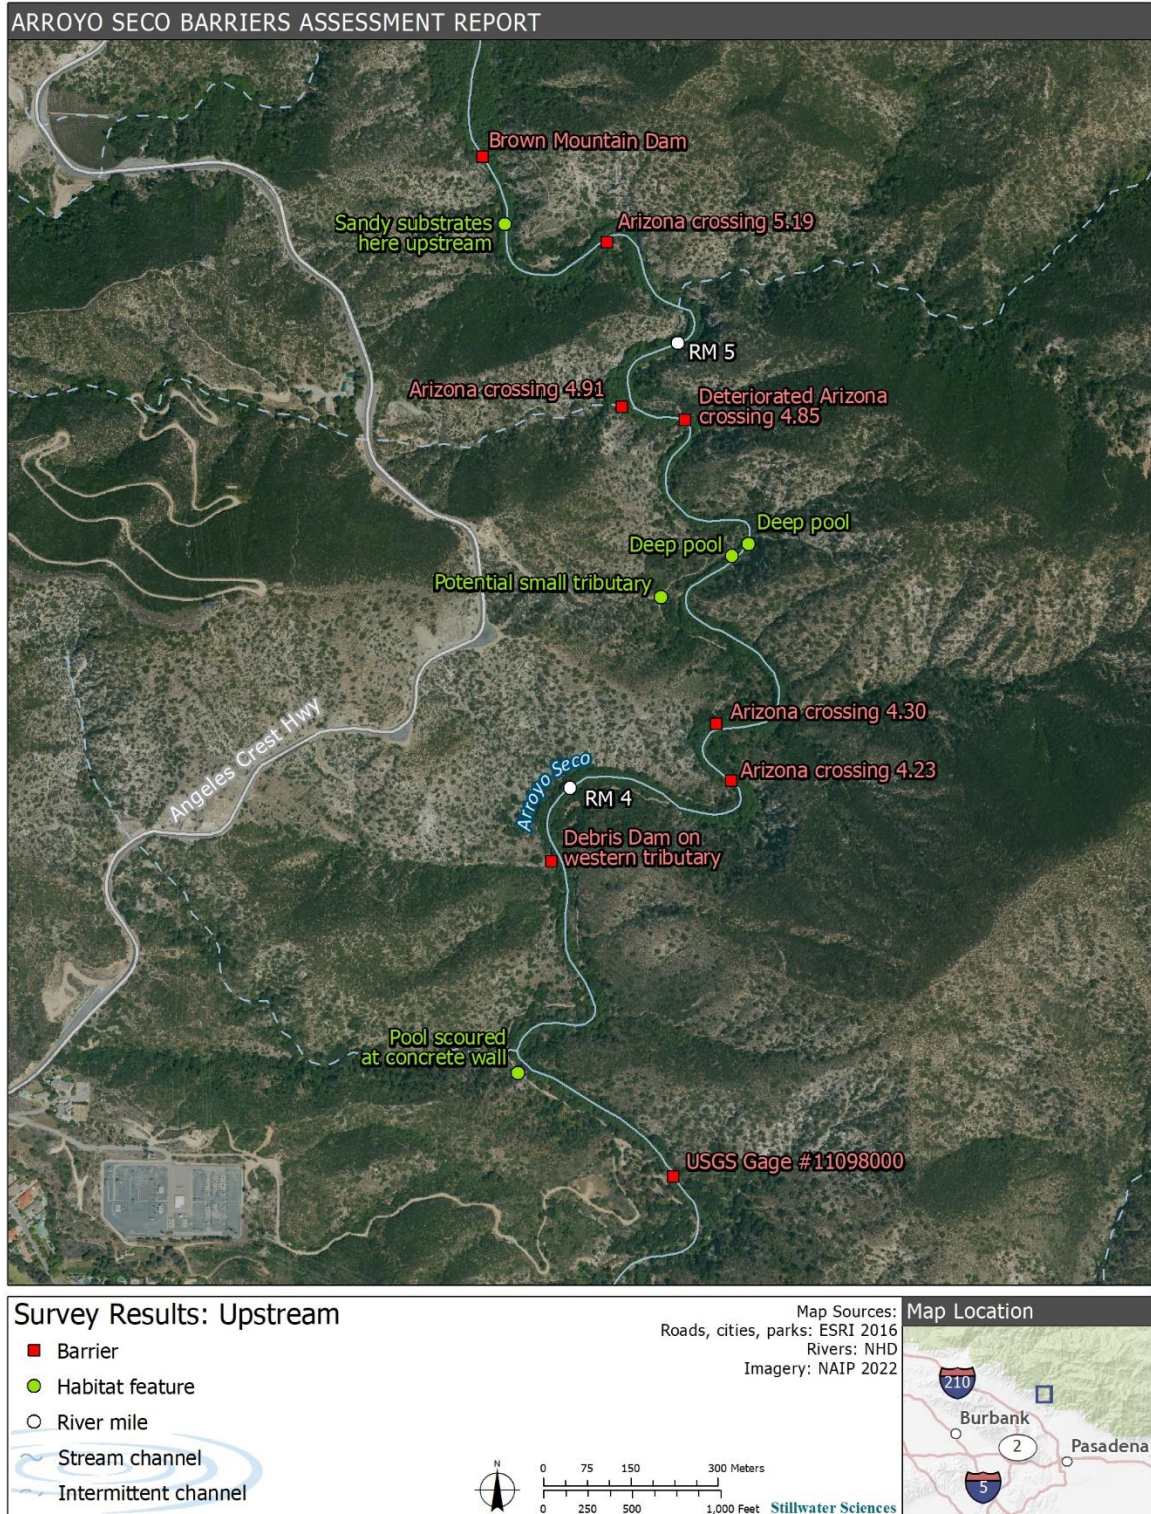
Figure 3. Barrier assessment survey results within the upstream reach of the Arroyo Seco.
